## **Development of a New Elevator Addition System for Aged Residential Buildings**

**Hitoshi Ogawa**, Seiichi Fukao, Shinji Yamazaki,  
Katsuhiro Kobayashi, Kozo Kadowaki, Susumu Minami  
Tokyo Metropolitan University,  
192-0397, 1-1Minamiosawa, Hachioji, Tokyo, Japan  
ogawa-hitoshi1@c.metro-u.ac.jp

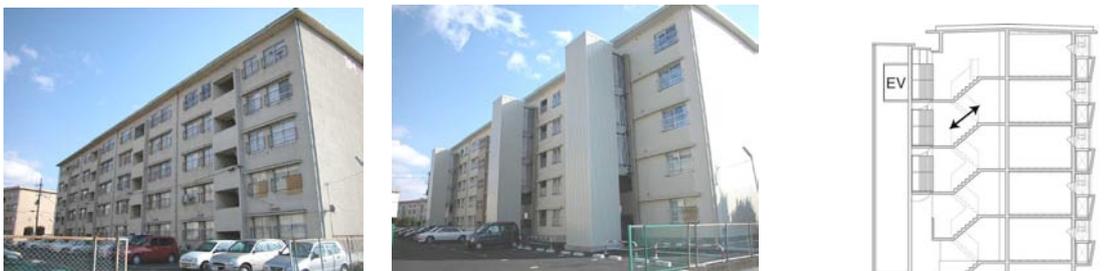
**Figure 1. Building before and after the renovation work involving the addition of elevator towers, and section view**

Firstly, we analyzed architects drawings of approximately 30 public residential buildings to which elevators have been added, and classified the buildings according to type. The most common type is that of buildings with the addition of an elevator tower to the outside of each of the staircases in the building. This method does not result in totally barrier free access to the dwellings because the elevator car has to stop at the landings of stairways, so that residents have to go up or down half the story height on foot.

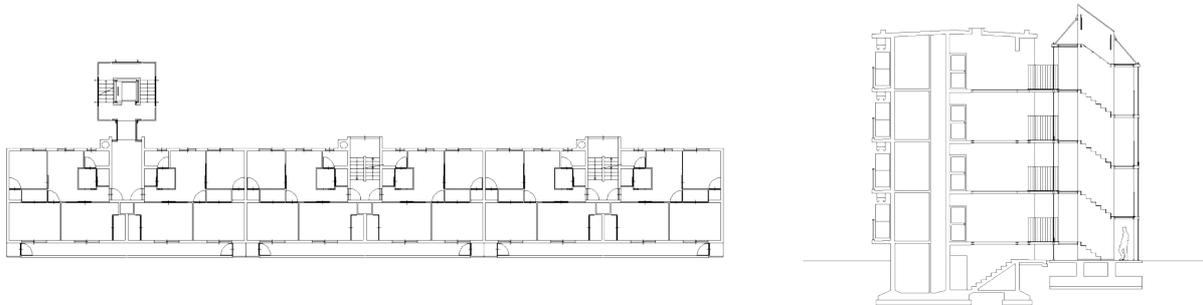
**Figure 2. Plan and section of the building with the new elevator system**

The new method we propose is an elevator tower unit consisting of an elevator shaft and stairs installed in a spiral design encircling the shaft. The construction is very simple. Firstly, the tower unit is installed on the outside of the existing staircase. Next, the existing stairs are removed and new floors are installed in the vacant stairwell on each floor level. Finally, the tower unit is connected with these new floors.

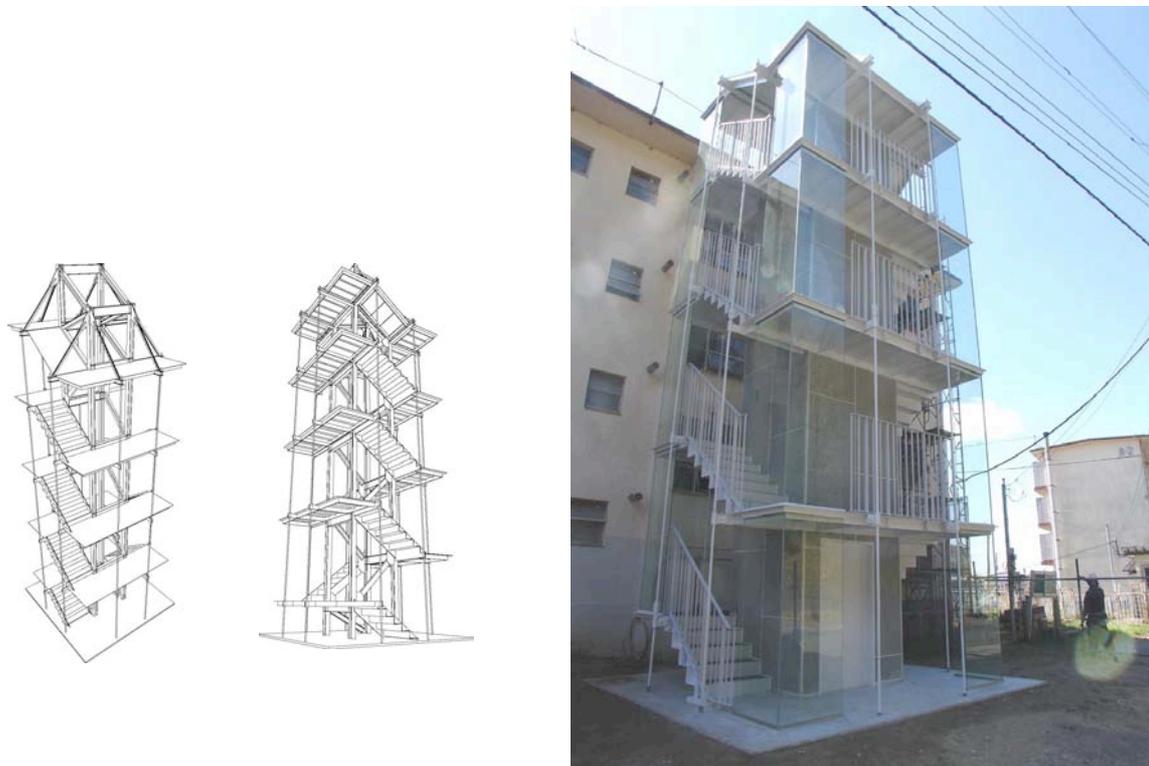
**Figure 3. Structural diagrams of new system and photograph of the new elevator addition system applied**

We designed this system to be compatible with a compact elevator. In Japan, elevators are generally high quality, but large and expensive. Although large elevators are structurally stable, it makes the existing staircase dark and unattractive. So, we propose a structural system that uses slender tension rods around a compact elevator shaft, which provides not only structural enforcement, but also gives a lighter impression of the elevator tower unit.

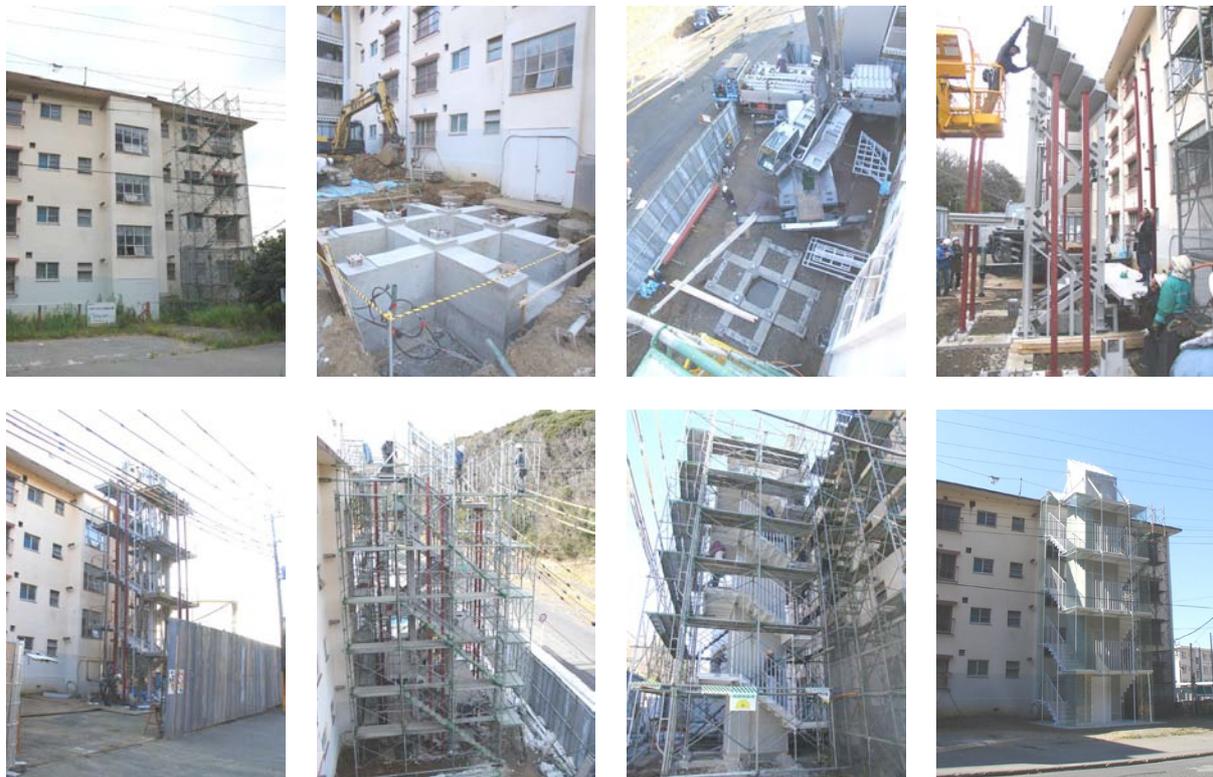
**Figure 4. Process photographs of construction site**

After finishing the design in detail, steel pieces were fabricated in a factory. At the same time, the ground was excavated and the foundations were laid. After finishing the prefabrication, the steel pieces were delivered to the site and the steel skeleton was erected. Then, the steel rods around the elevator shaft were tensioned. Hereafter, construction work was carried out in series; the exterior wall of the elevator shaft was set, the elevator shaft was covered with a roof, metal work was completed, the steelwork was painted, glass panels were set in the stair landings and the floors were finished.

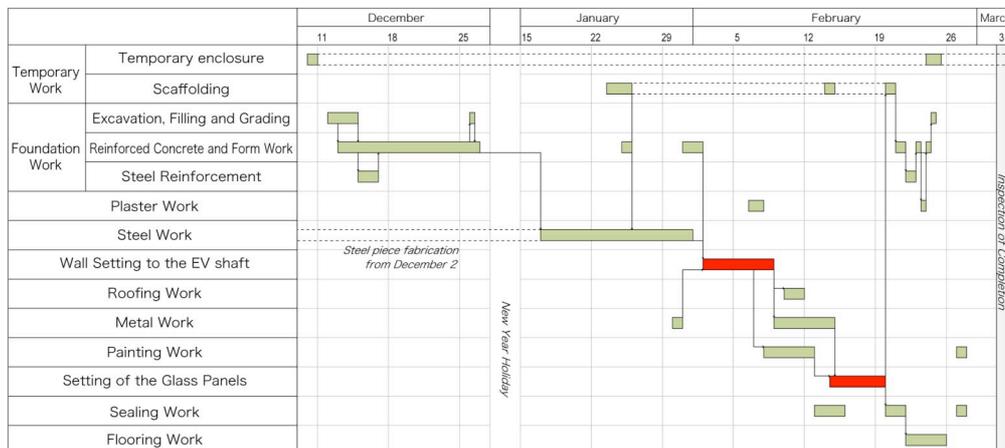
**Figure 5. Construction flow diagram showing relationship between each task**

The construction flow diagram shows that in the first half of construction, tasks were completed one at a time, such as laying the foundations and erecting the tower unit. In the latter half of construction, many tasks were carried out simultaneously. When tasks are tightly scheduled, it is essential to prioritize the wall setting to the elevator shaft and the setting of the glass panels. Once these tasks are completed, other tasks can begin. Thus, it is important for reducing the construction period that working these tasks promptly and scheduling tasks to be worked simultaneously with other works where possible.
